Re: **MILESTONE INSPECTION**
Please keep with your Association records

Enclosed is a copy of the Milestone Inspection for Five Towns of St. Petersburg, No. 302, Inc., Dartmouth Building performed on March 1, 2023. Please keep this with your copy of the documents.

RE: 5501 80th Street N. (five story building)
St. Pete, FL 33709

Pursuant to your request, I visited the above-referenced property on February 24, 2023 with regard to the Structural Engineering Milestone Inspection. The purpose of this inspection was to determine the condition of the building and to provide a report based upon my findings. I met with Mr. Ron Bonollo, the Vice president of the Association. At that time, I walked around the building with Mr. Bonollo, whereby we viewed the roofs, staircases, electrical rooms, fire rooms, elevator rooms, private storages, the walkways (breezeway) of each floor and the laundry rooms of the building. Attached are a total of 20 photographs which identify and describe the areas. These photographs are marked Fig. 1 thru Fig. 20 and are attached to this report.

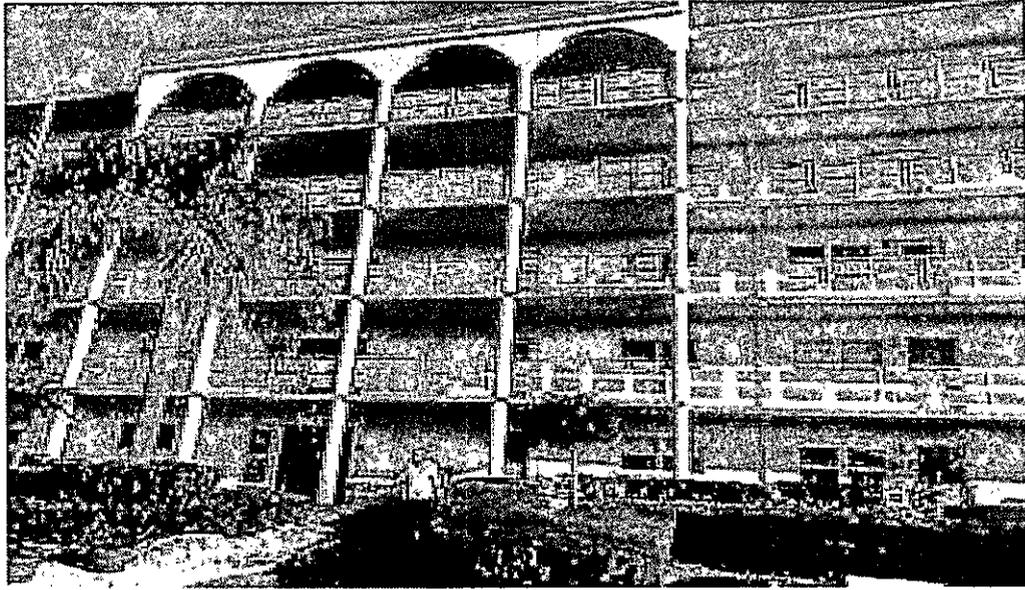
Fig.. 1

The building is a five-story condominium project (see Fig. 1 and Fig. 2), with the 1st floor slab on grade as level 1 living area. The building is constructed with steel bar joists that support the metal decks and concrete slabs, which were built in 1972, making the building approximately 51 years old. The bar joists are supported by masonry walls (CMU), concrete columns and concrete beams. The columns and CMU walls are supported by conventional footing. The exterior walls of this building were constructed by CMU walls and covered with stucco. The drywall ceiling is attached to the bottom of the bar joists. There are some areas that contain a drop ceiling which means the ceiling is not directly attached to the bottom of the bar joists. Therefore, the bar joists are covered, and one is not able to see the condition of them. There is a total of 75 units in this condominium complex. There are 15 units per floor and are numbered 101-116 (1st floor, the number 13 was not used at each floor). The bar joists span approximately 26 feet to 28 feet and are supported by CMU walls between the units. I was able to review the original the structural plans of this building which were created by O.E. Olsen & Associates. These plans indicate that the building is approximately 386 feet by 54 feet. The building was painted approximately one year ago. There are two set of stairs located at the east and west sides of the building (see Fig. 3 and Fig. 4). The exterior of the stair's walls are covered with bricks. It appears some time
